C-5149-14-H

Report

Date: October 18, 2010

Re: Structural Investigation of
Partial Collapse of the Main Building
PJSA ISD T-Stem Early College High School
714 E. U.S. Highway 83, Pharr, Texas
FLA 2010.47

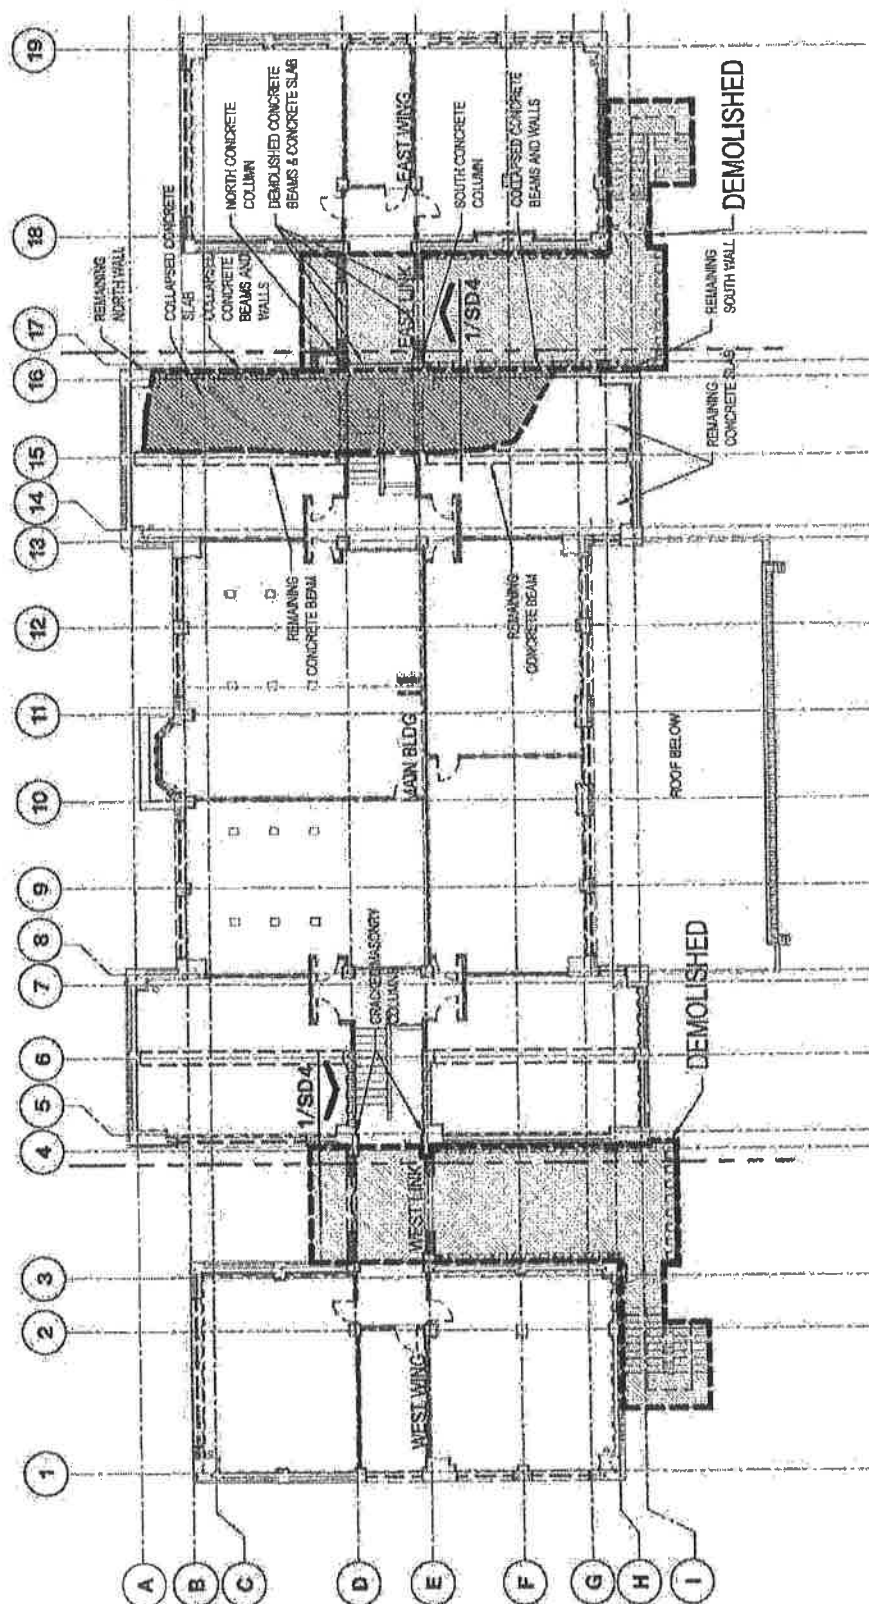
The East Link structure was completely demolished with the exception of some rebar spanning between the buildings. During the demolition of the link, an approximately 12 ft by 60 ft long section of the west side of Main Building was also damaged and collapsed. See plans on drawings SD2 and SD3 and Photos 1 to 17. The collapsed members include the concrete beams and slab at the second floor and roof, load bearing clay tile and brick veneer walls, exterior masonry columns, and concrete masonry unit infill at the wall opening. Part of the second floor and roof slab is still hanging by the rebar and the two wing walls at the north and south of the building are still remaining but have suffered severe damages and separation. The floor and roof beams had rotated and pulled out from the masonry walls, leaving a pocket in the walls. See Photos 2, 11, and 17. It appears that the collapse stops at the first interior beam along Grid 15. See plans on drawing SD2 and SD3.

We recommend that the partially collapsed slab be removed to the face of the beams at the first interior grid line 15. See plan on drawing SD2. The remaining clay tile and masonry walls at the north and south of the building shall be removed to the west of grid 15. New steel structure shall be installed to replace the collapsed slab. Install concrete masonry unit (CMU) wall to the inside of existing wall along grid line A and grid line H and between grid lines 13 and 15 and turn the corners to the masonry columns at B-13

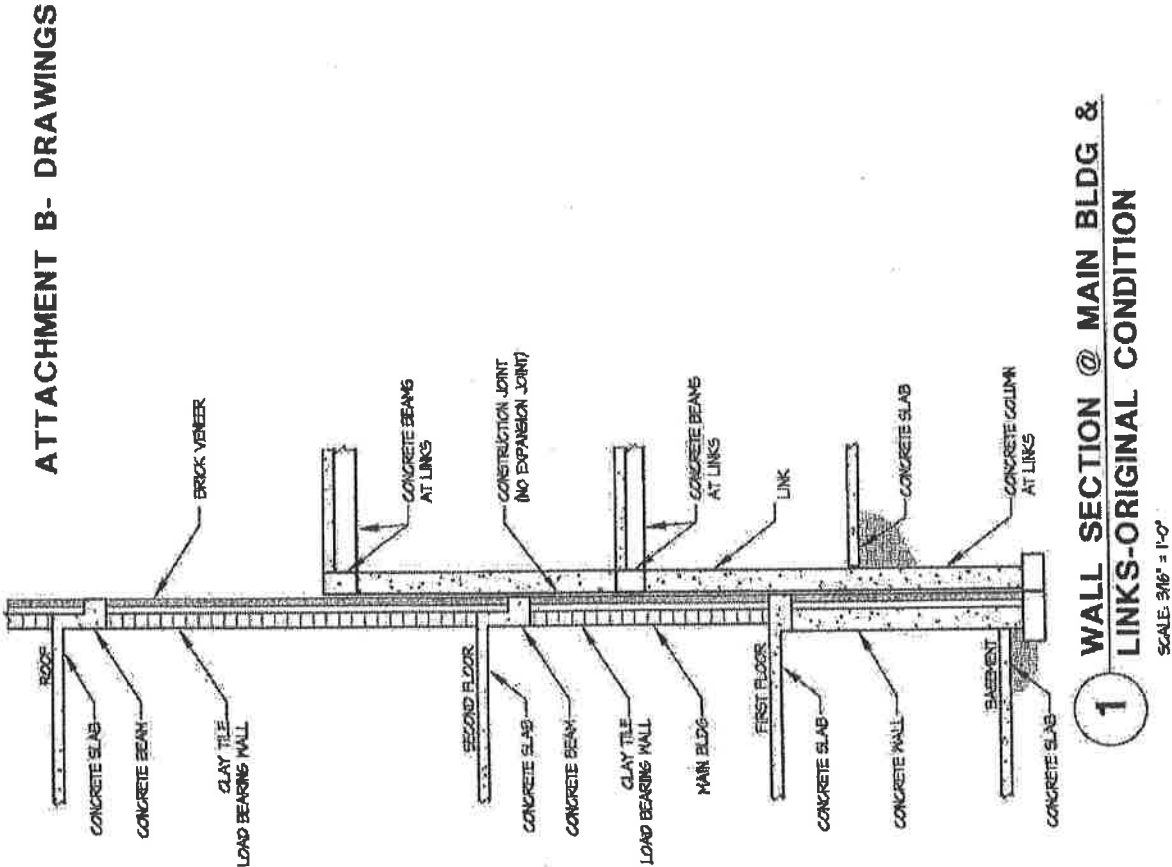
SD4

columns and beams poured against and plastered around the existing masonry columns. The masonry columns are part of the load bearing walls supporting the floor and roof of the Main Building. See wall section on attached drawing SD4.

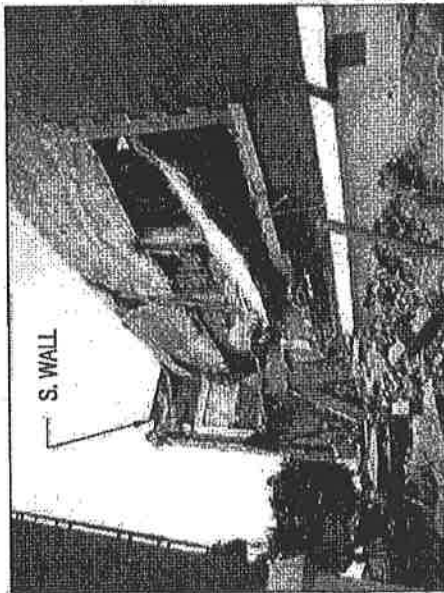
1 - COLLAPSED SLAB AND REMAINING SOUTH WALL

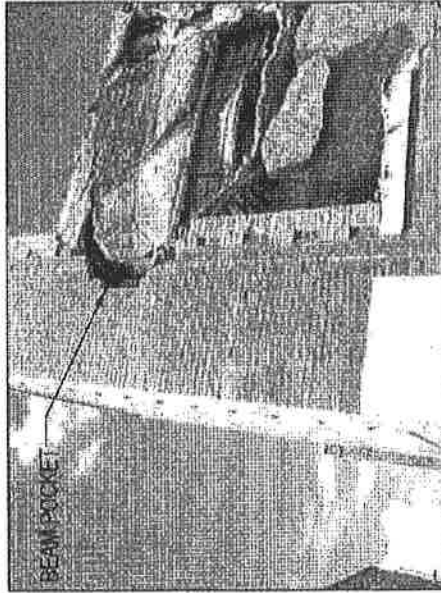
2 - BEAM POCKET AT SOUTH WALL

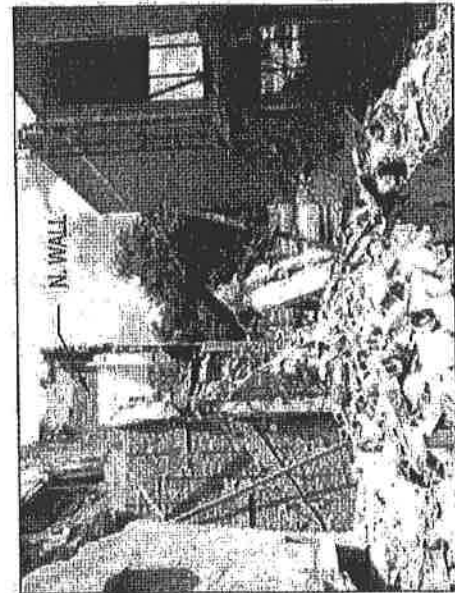
3 - COLLAPSED SLAB AND REMAINING NORTH WALL

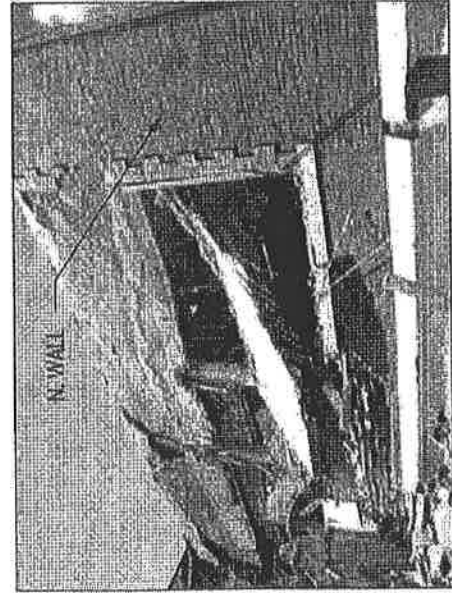
4 - COLLAPSED SLAB AND REMAINING NORTH WALL-FACING EAST

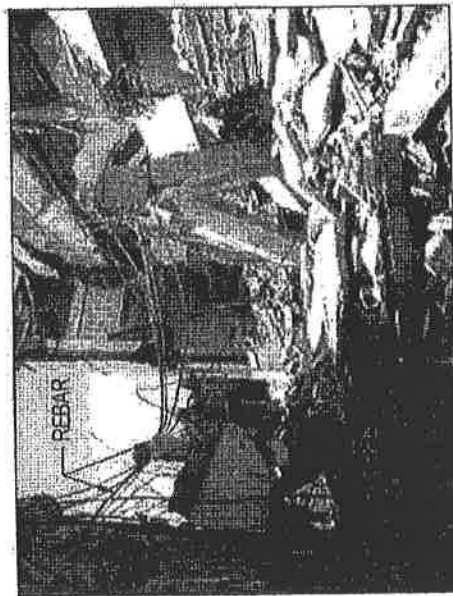
5 - COLLAPSED STRUCTURE AT EAST LINK SHOWING REMAINING REBAR

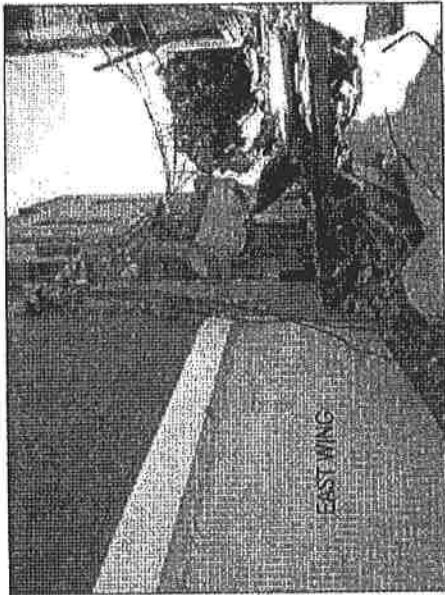
6 - COLLAPSED EAST LINK AND EAST WING

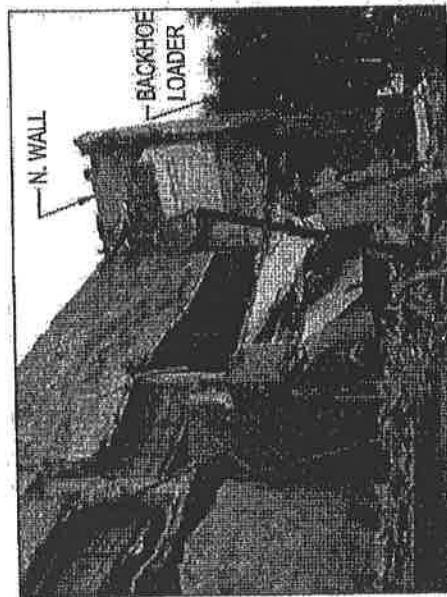
7 - BACKHOE LOADER NEAR NORTHEAST CORNER

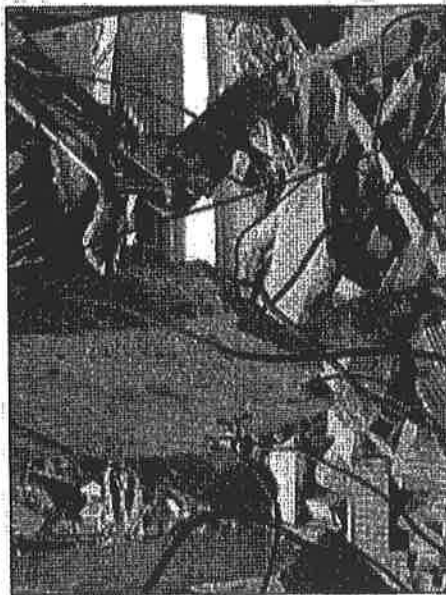
The origin of the force that starts the failure of the north masonry column is related to the demolition means and methods. It could be excessive force from the high impact chipping hammer working on the concrete frame. As mentioned previously, the collapse of the structure is probably due to a combination of several factors: Contractor's means and methods during the demolition and lack of protection of the existing structure, issues related to the original design and construction, and pre-existing conditions. The building was designed primarily as concrete frame structure except clay tile wall was designed as load bearing wall to support the concrete slab and beams at the exterior of the building. Individual columns supporting the exterior concrete beams are made of clay tiles or bricks, forming a box shape vertical structure. There is no concrete or reinforcing inside the columns and there is no connection between the concrete beams and the clay tile columns other than a beam pocket. As a result of the lack of restraint at the top of the column any significant lateral force acting on the column will destabilize the column. The construction method of the concrete columns supporting the Links also contributes to the failure of the building. The new concrete columns were cast against the existing masonry walls and columns without expansion joint and the columns were plastered together and creating a bond between them. This condition does not allow the columns to move independently and allows force transfer between them; and as a result, impact from the chipping hammer hitting the concrete column in the Link could have created distress in the masonry column in the Main Building. Another factor that contributes to the collapse of the structure is the pre-existing conditions of the clay tile walls and masonry columns. Pre-existing conditions include cracks and spallings in the clay tiles and masonry which would have weakened the structure and reduced the load carrying capacity.

[9] - HIGH IMPACT CHIPPING HAMMER

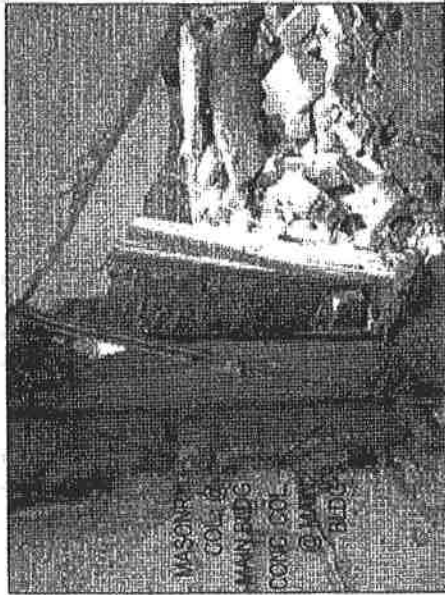
[10] - PARTIALLY COLLAPSED COLUMN AT EAST LINK GRIDS DET

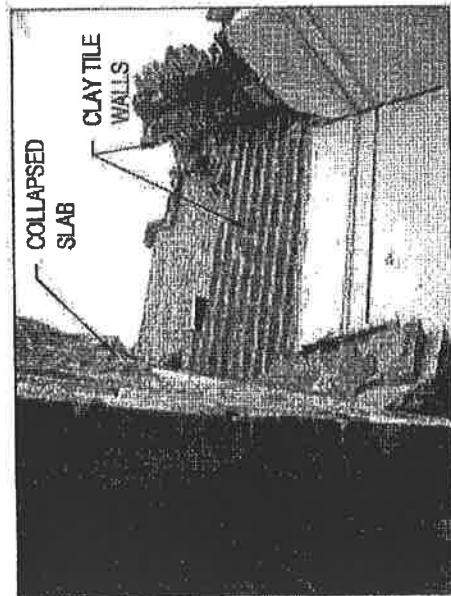
[11] - COLLAPSED ROOF SLAB AT NE CORNER

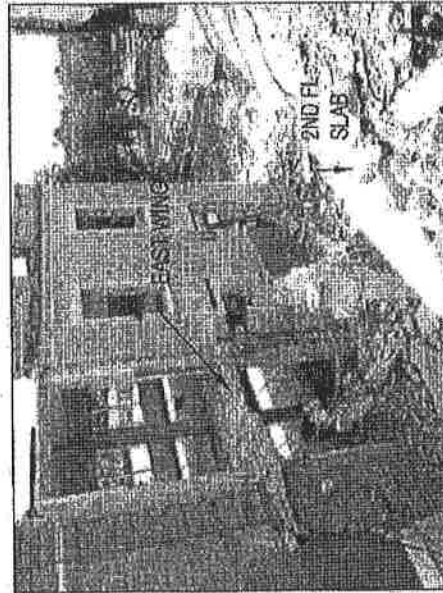
[12] - COLLAPSED 2ND FLOOR SLAB & EAST WING SLAB

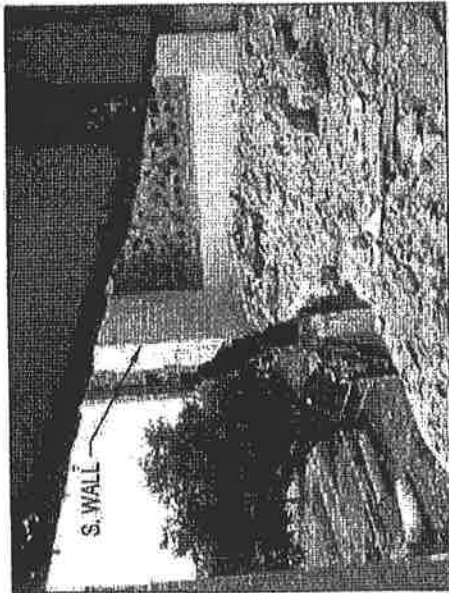
13 - COLLAPSED 2ND FLOOR SLAB AT S/E CORNER

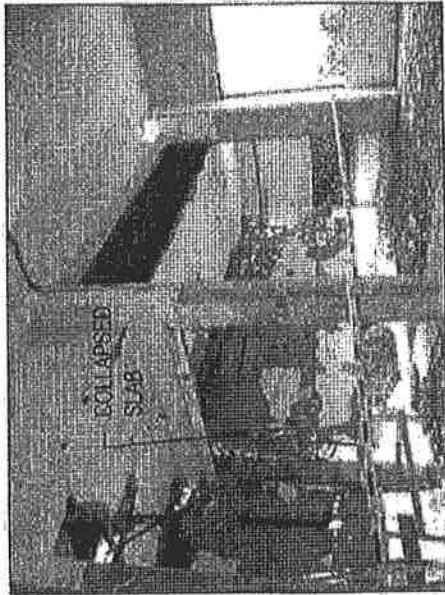
14 - COLLAPSED ROOF SLAB LOOKING FROM INSIDE OF BLDG

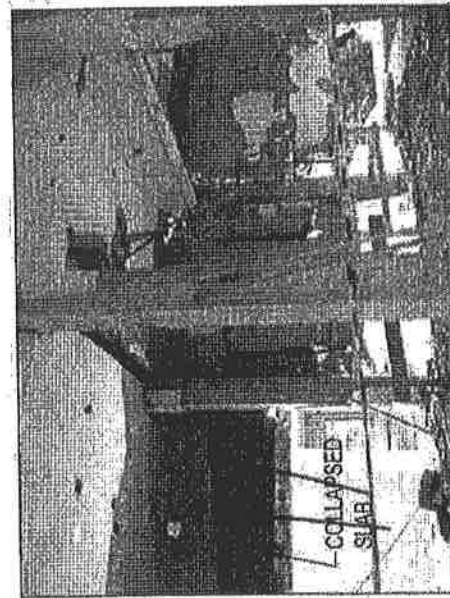
15 - COLLAPSED ROOF SLAB LOOKING FROM INSIDE OF BLDG

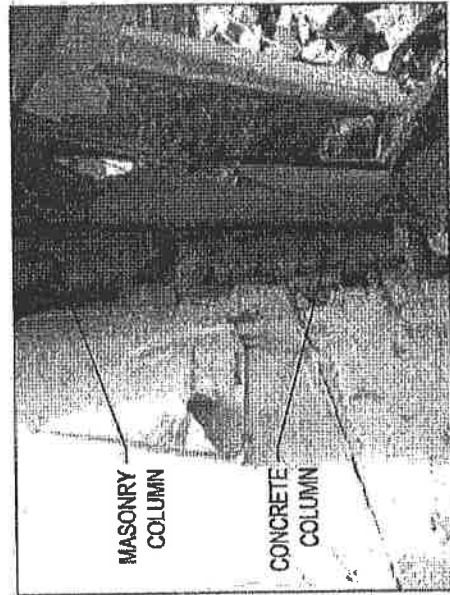
16 - PARTIALLY COLLAPSED COLUMN AT EAST LINK GRIDS D&T

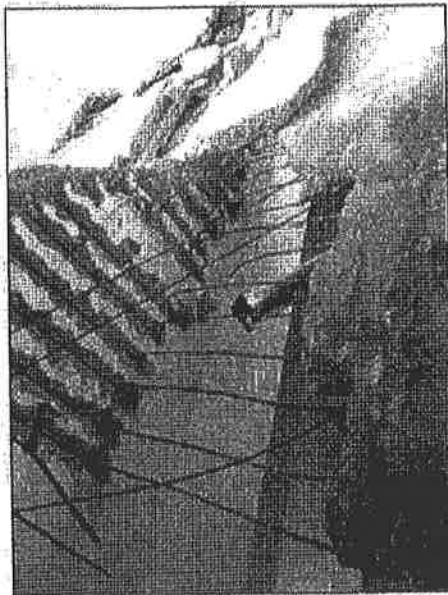
17 - BOTTOM OF COLLAPSED 2ND FL SLAB SHOWING DE-BONDING OF REBAR

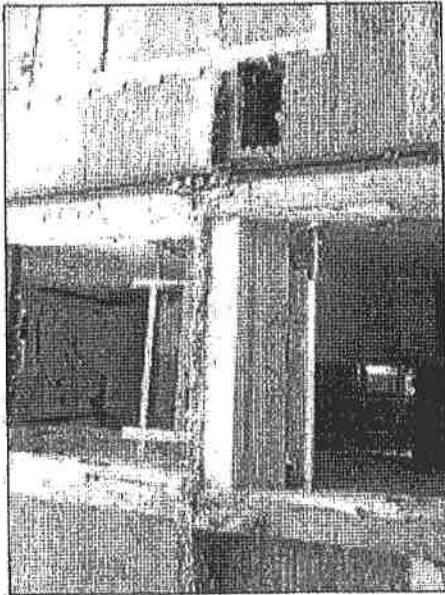
The West Link structure was almost completely demolished except the concrete columns and tie beams attached to the Main Building. See Photos 18, 19, and 20. In general, the masonry walls of the Main Building appear to be in satisfactory condition except at the two hollow masonry columns located at the stair. The masonry columns are sitting on top of concrete columns which are terminated near the floor level. Structural cracks are observed above the concrete columns. See Photos 21 and 22. These cracks and the hollow masonry columns must be addressed prior to future work on the building.

18 - DEMOLISHED CONCRETE FRAME AT WEST LINK & WEST OF MAIN BLDG

Prior to further demolition, the existing load bearing walls shall be strengthened. We recommend the installation of CMU walls similar to the east side. CMU walls shall be installed along the exterior wall at grid line 5 and turn the corners to grid line 8 along grids A and H. The wall shall terminate at masonry columns B-8 and G-8.

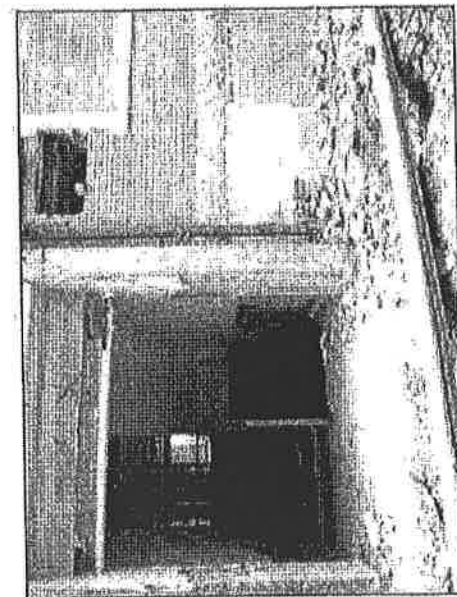
19 - DEMOLISHED CONCRETE FRAME AT WEST LINK & WEST OF MAIN BLDG

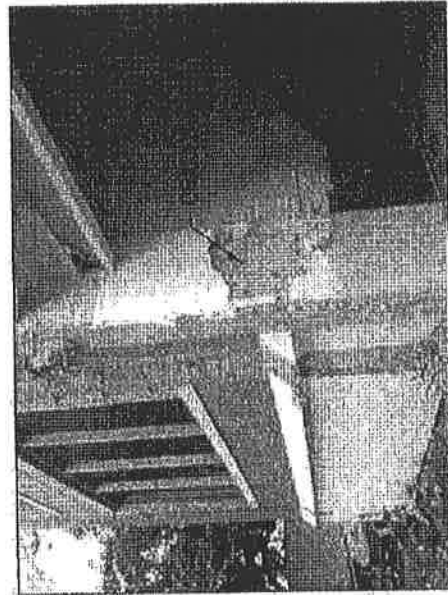
20 - CONCRETE MASONRY COLUMN AT WEST OF MAIN BLDG SHOWING CRACKS

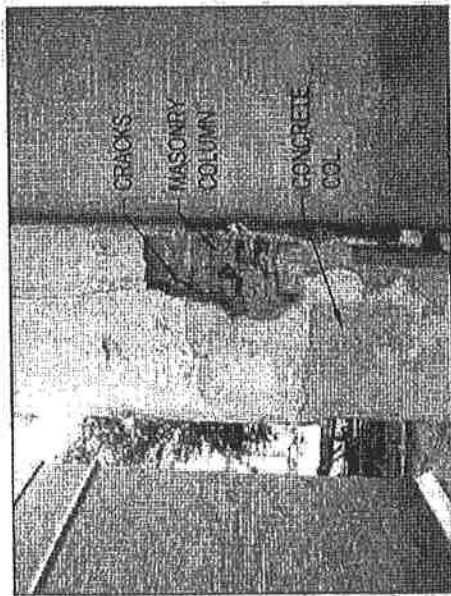
21 - CRACKED MASONRY COLUMN AT WEST OF MAIN BLDG

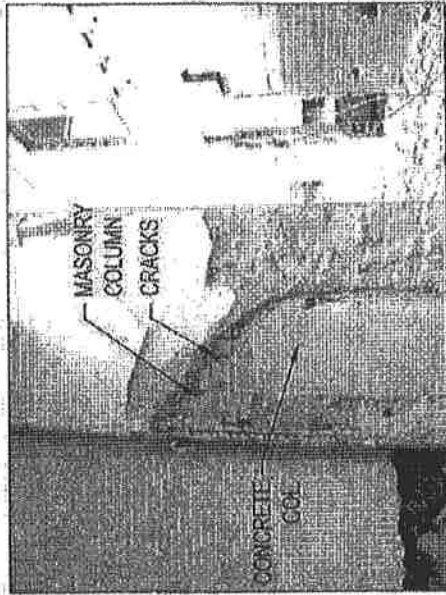
22 - CRACKED MASONRY/CONCRETE COLUMN AT WEST OF MAIN BLDG
